Observation:

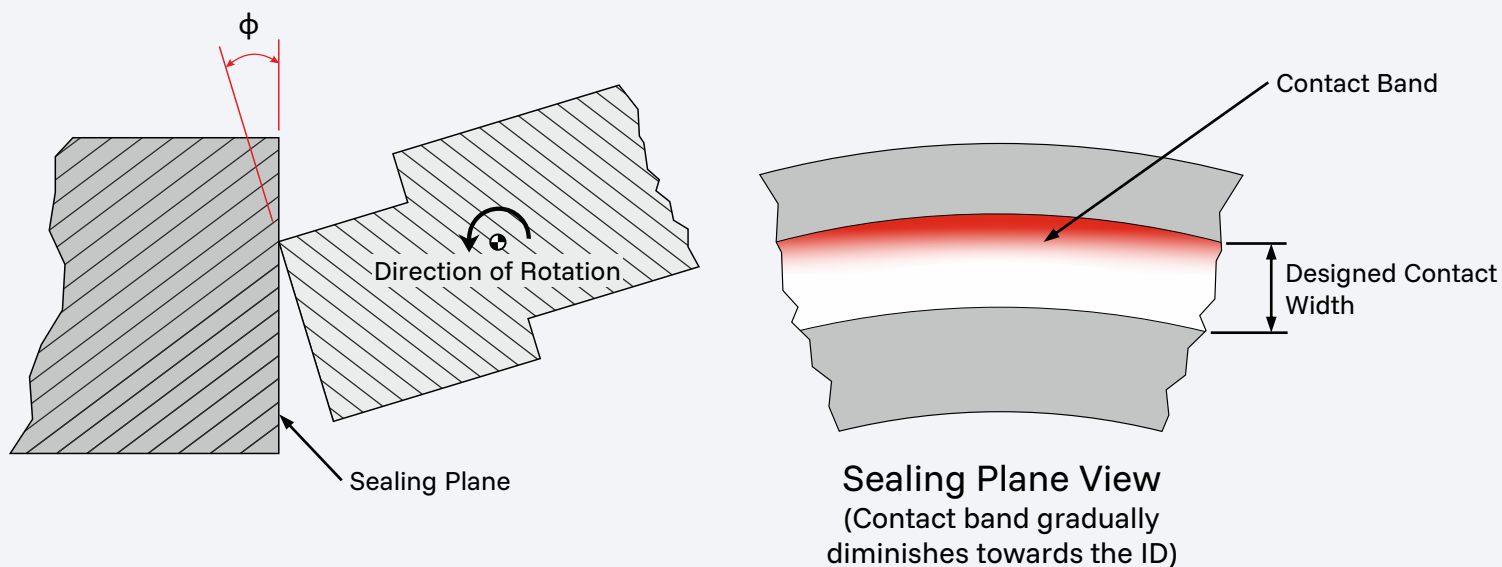
Image 1: Illustration of Angular Rotation and Sealing Plane View

It is the **angular rotation** of the seal ring cross-section that produces seal face tilt, resulting in increased contact pressure toward either the outer diameter or inner diameter.

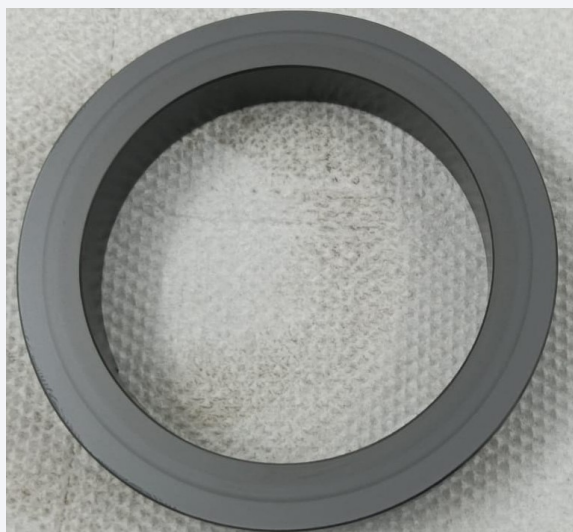
- Seal ring shows heavy, concentrated contact marks toward the OD, with contact gradually diminishing toward the ID.
- Mating ring displays a noticeably narrower contact band compared to the designed contact width
- Possible edge chipping or micro-fractures at the OD of the seal ring due to localized overloading.
- Loss of flatness becomes evident when the faces are checked on a lapping plate.

Image 2: Narrow Contact Band on Sealing Surface (Mating Ring)

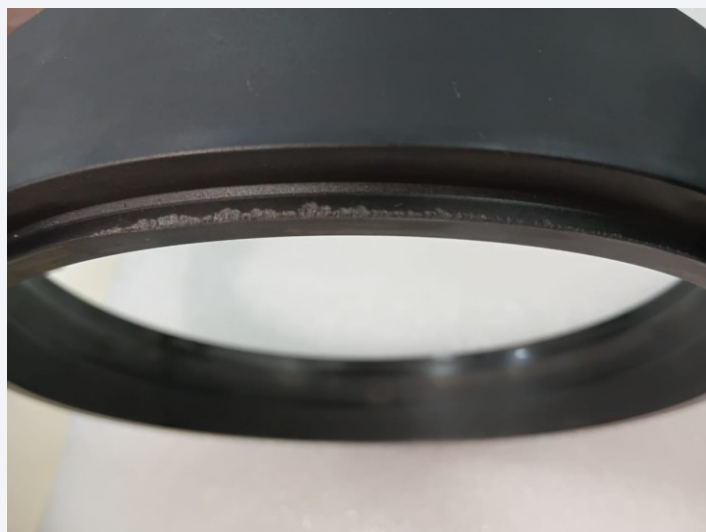
Image 3: Edge Chipping at OD of the Seal Ring.

Negative coning is primarily caused by **over-pressurization**, where excessive hydraulic load distorts the **seal ring cross-section** into a slight **conical shape**, resulting in heavier contact at the outer diameter of the sealing face.

Sr	Possible Cause	Corrective Action
1	Faces not flat due to over-pressurization	<ol style="list-style-type: none"> 1) Compare seal design pressure with operating pressure. <ol style="list-style-type: none"> a) If seal design pressure is lower, select a seal rated above the maximum operating pressure. b) If seal design pressure is higher, verify actual seal chamber pressure and pressure balance to ensure no unintended pressure amplification due to chamber configuration, balance ratio, pressure transients, or abnormal pressure buildup.
2	Faces not flat due to incorrect lapping (concavity of seal face)	<ol style="list-style-type: none"> 1) Re-lap seal faces to restore proper flatness. 2) Ensure proper lapping plate condition and procedure to avoid concavity or taper. 3) Verify final face geometry using optical flat or monochromatic light per manufacturer's guidelines; where unspecified, achieve a maximum of 2 light-bands.
