Observation:

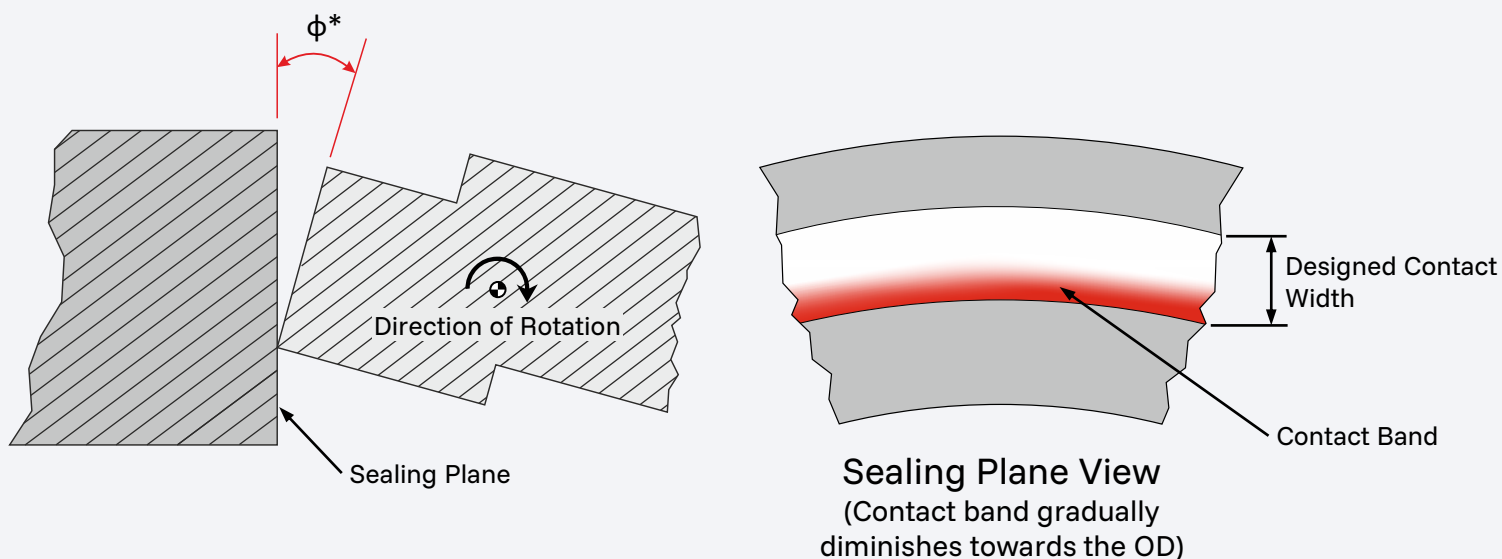
Figure 1: Illustration of Angular Rotation and Sealing Plane View

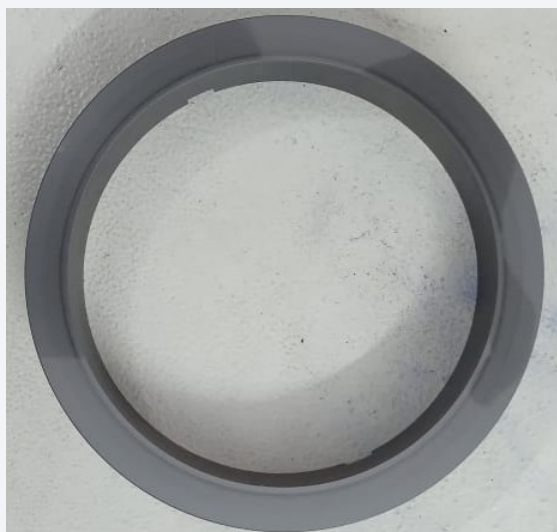
During seal face inspection, the seal ring and mating ring exhibit a **distinct tapered contact pattern** where the **inside diameter (ID)** of the sealing plane shows **noticeably higher wear** than the outer diameter (OD). Typical visual indicators observed on the seal ring and mating ring include:

- Seal ring shows heavy contact marks concentrated toward the ID, with contact gradually fading toward the OD.
- Mating ring displays a narrower contact band near the ID compared to the designed contact width.
- Possible edge chipping or micro-fractures at the ID of the seal ring due to localized overloading.
- Seal faces fail flatness verification during optical inspection.

Figure 2: Narrow Contact Band on Sealing Surface (Mating Ring)

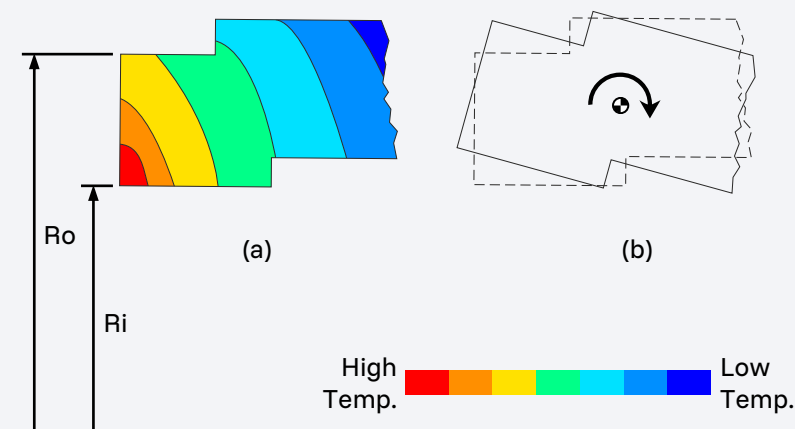
These visual indicators suggest that the seal faces did not remain parallel during operation because of **non-uniform temperature distribution** across the seal face. Thermal gradients within the seal face body induce differential expansion, producing a conical face distortion known as **Thermal Distortion** or **Positive Coning**.

Figure 3: Thermally Induced Distortion:
a) Thermal gradient across seal ring,
b) Cross-sectional rotation (Positive Coning)

Positive coning is primarily driven by **thermally induced radial taper** resulting from **non-uniform temperature distribution** within the seal face. Frictional heat at the seal interface creates axial thermal gradients, with the face region operating hotter than the rear section (*Fig. 3*). The hotter face end expands more than the cooler back, causing cross-sectional rotation and a *radial taper* converging toward the inside diameter, leading to heavy ID contact, known as **Thermal Distortion** or **Positive Coning**.

Sr	Possible Cause	Corrective Action
1	Faces not flat due to thermal distortion	<ol style="list-style-type: none"> 1) Review seal thermal design against operating conditions. <ol style="list-style-type: none"> a) If the seal is not designed for the generated heat load (speed, face load, lubrication regime), select a design with higher thermal capacity, improved cooling features, or suitable face materials. b) If the seal is thermally rated for the application: <ol style="list-style-type: none"> i. Ensure there is no unintended heat buildup from inadequate flush flow; increase flush rate or review flush plan suitability if required. ii. Check seal chamber circulation to prevent hot fluid stagnation by reviewing chamber design, inlet/outlet locations, and flow paths. iii. Verify effectiveness of cooling arrangements (e.g., heat exchanger, jackets) and ensure coolant flow and temperature are within design limits. iv. Review face lubrication to ensure operation is not in mixed or boundary lubrication due to low pressure, poor fluid properties, or inadequate flush.

2	Faces not flat due to incorrect lapping (convexity of seal face)	<ol style="list-style-type: none"> 1) Re-lap seal faces to restore proper flatness. 2) Ensure proper lapping plate condition and procedure to avoid concavity or taper. 3) Verify final face geometry using optical flat or monochromatic light per manufacturer's guidelines; where unspecified, achieve a maximum of 2 light-bands.
