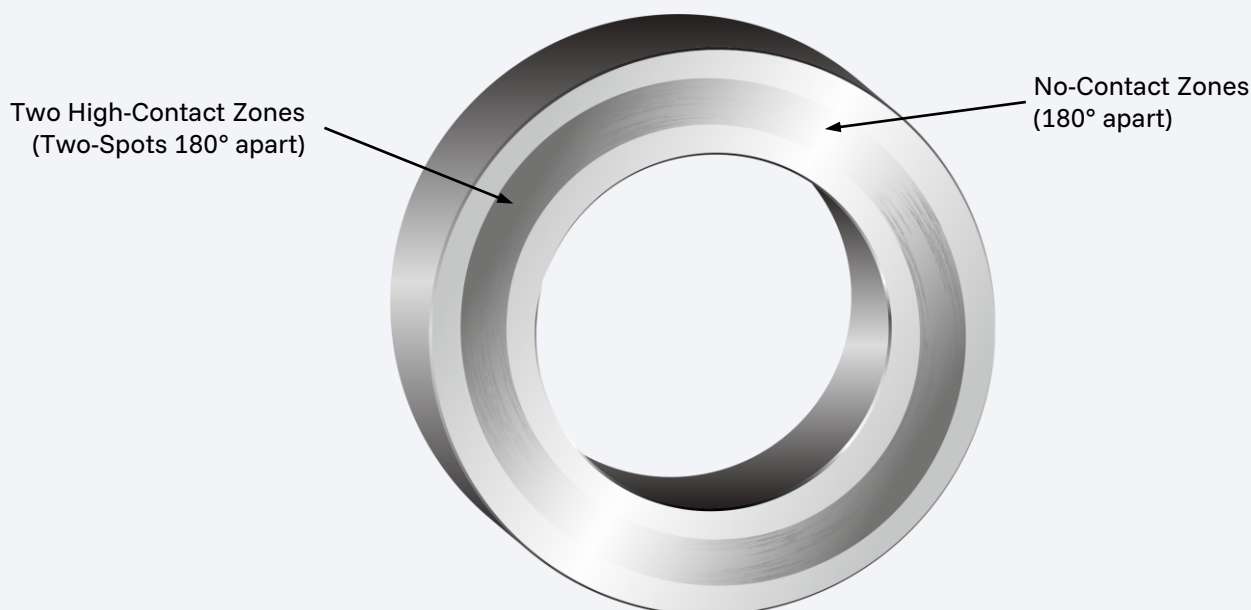
Figure 1: Illustration of a Mating Ring with Two-Spot Contact

During seal face inspection, the mating ring exhibits **two dominant high-contact zones**, typically positioned approximately **180° apart**, while the remaining circumferential regions show reduced or negligible contact. The seal ring generally shows full **360° contact**. Typical visual indicators include:

- Two distinct, heavily worn contact spots on the mating ring surface, diametrically opposed to each other. While contact intensity gradually fades away between the two high-contact regions.
- Seal ring shows full circumferential contact.
- Possible scoring on the mating ring surface, cross-hatched or circular scratches due to particles entered in gaps of the out-of-flat mating surface.
- Seal faces fail flatness verification during optical inspection.

These observations indicate that the sealing faces did not remain parallel during operation. Instead, the mating ring adopted a globally distorted shape, resulting in two dominant contact zones, commonly referred to as **Two-Spot Contact**. Scoring is secondary manifestations that support diagnosis but are not critical to the failure mechanism itself.

Two-Spot Contact occurs due to **global distortion of the gland or seal plate**, which prevents the mating ring from remaining flat and parallel to the seal ring during operation. This distortion causes the mating ring to develop two dominant high-contact zones, typically located approximately 180° apart.

The distortion is mostly introduced during installation and assembly. Excessive or uneven tightening of gland bolts, improper bolt tightening sequence, or over-torquing can elastically or plastically deform the gland or seal plate. When the distorted gland or seal plate **clamps the mating ring**, the mating surface adopts a **non-flat geometry**, leading to **localized contact** rather than uniform face loading.

Sr	Possible Cause	Corrective Action
1	Gland / Seal Plate Distortion	<ol style="list-style-type: none"> 1) Verify Gland / Seal Plate bolt torque against manufacturer recommendations; If bolt loading is suspected to be excessive or non-uniform: <ol style="list-style-type: none"> a) Use calibrated torque tools and follow a cross-pattern tightening sequence to achieve uniform bolt loading. b) Avoid reusing overstressed, stretched, or damaged bolts, which can lead to uneven clamping forces. c) Train installation personnel on correct bolt torque and tightening sequences. 2) Review Gland / Seal Plate thickness and material selection for adequate rigidity; If distortion is suspected under operating or assembly loads: <ol style="list-style-type: none"> a) Upgrade to a thicker, stiffer, or reinforced plate. 3) Verify gasket selection and installation for uniform support; If non-uniform gasket compression is suspected: <ol style="list-style-type: none"> a) Use gaskets with appropriate thickness and hardness to minimize excessive compression. b) Replace gaskets showing signs of uneven compression, damage, or permanent set.

2	Lack of Flatness or Squareness	<ol style="list-style-type: none"> 1) Inspect flatness at the respective mating surfaces of the <i>Gland / Seal Plate–Seal Chamber</i> and <i>Gland / Seal Plate–Mating Ring</i> using bluing or optical methods. Correct surface errors by re-machining or replacing parts if required. 2) Ensure the mating surfaces are free of nicks, burrs, or damage before installation. 3) Ensure Gland / Seal Plate squareness to the shaft centerline during installation to prevent angular misalignment.
